REPAIRING SCREW OR NAIL POPS (GA-222-09)

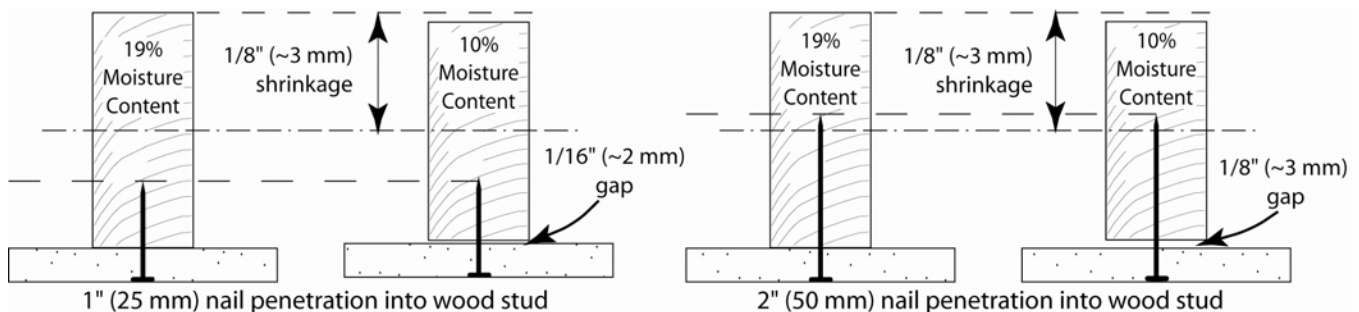
The protrusion of screw or nail heads above the gypsum panel surface is caused by one or more of the following:

- Lumber shrinkage occurring after gypsum panel product application,
- Loose attachment of the gypsum panel product to the framing,
- Improperly aligned, twisted, bent, warped, or bowed framing,
- Incorrect fastener length, or
- Improper fastening

Fastener pops are largely caused by lumber shrinkage due to initially high moisture content lumber. Overly long fastener length contributes to the problem and fastener penetration into wood framing should not exceed 7/8 in. (22 mm) for nails, 5/8 in. (16 mm) for screws. For fire-resistance rated systems use fastener lengths specified in the listing.

Fastener pops are repaired by reattaching the gypsum panel product to the framing by driving a new screw or nail of the proper length into the same framing member about 1-1/2 in. (40 mm) from the popped fastener. Apply sufficient pressure to the gypsum panel to bring the back surface into firm contact with the framing member to which it is being reattached. Remove the fastener or reseal the popped fastener so that it is just below the face of the gypsum panel. Remove any loose material before treating with joint compound and redecorating.
